# **Mir Photo/TV Survey (DTO-1118): STS-86 Mission Report**

Prepared by:  
**Image Science and Analysis Group**  
**Space Science Branch**  
**Earth Science and Solar System Exploration Division**

March 4, 1998

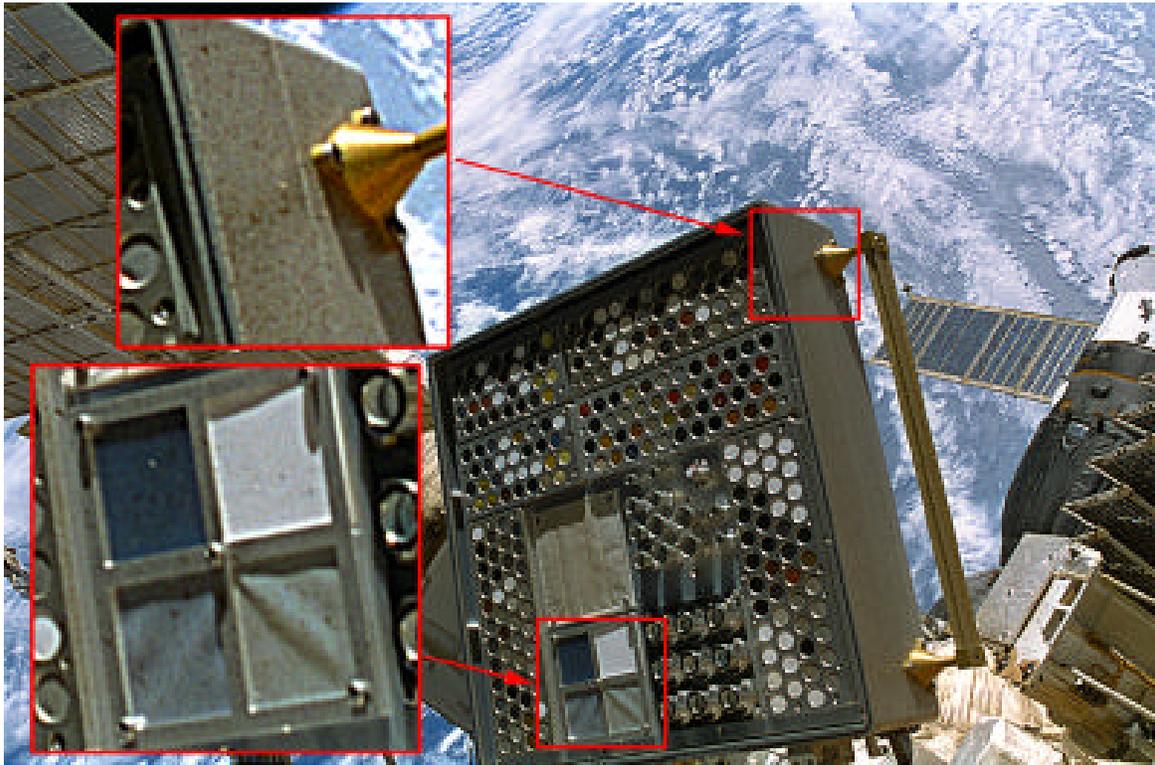
**Figure 7.3 EVA Image of POSA II Showing Contamination**

these deposits may have originated from multiple Orbiter waste water dumps and/or from Progress condensate waste leaks. Imagery of POSA II taken on STS-84 showed no indications of this type of contamination, however, these earlier images were of a lower resolution than the STS-86 EVA photography.
